M7.8 COASTAL ECUADOR EARTHQUAKE PRELIMINARY RECONNAISSANCE REPORT

By ABS CONSULTING, AN ABS GROUP COMPANY
MAY 31, 2016

Preliminary ABS Consulting Reconnaissance Report May 31, 2016

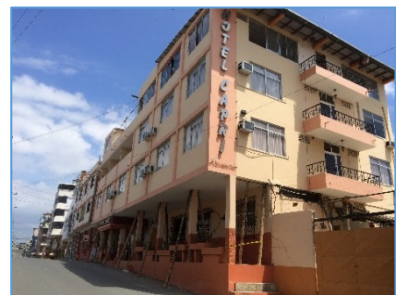
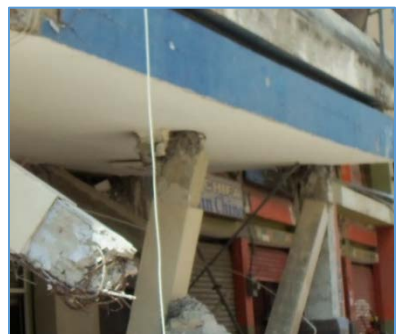
the older buildings can be considered extremely non-ductile in that, besides having small column dimensions, column ties are also small (less than #3 or 10mm diameter), widely spaced (tie spacing vs. column width, $s/h = 0.75$), and lacking modern seismic bends and cross-ties. In addition, the use of smooth (undeformed) reinforcing bars that are incapable of preventing the development of large concrete cracks is not uncommon.

Once the 1.5 inches (38mm) thick unreinforced concrete cover on the

small non-ductile columns spalls during earthquake shaking (as observed), very little of the concrete core of the column remains to support the buildings, with catastrophic results that results in subsequent loss of vertical supports. For example, for a 10 inch (250mm) square column, the remaining area after spalling is only 49% of the pre-spalled condition; for an 8 inch (200mm) square column, the remaining area after spalling is only 39% of the pre-spalled condition. This area of concrete would be applicable only if the columns were well confined with closely spaced ties (which they typically are not). *As a relative comparison, the minimum column dimension currently specified by ACI 318-11 for regions of high seismicity is 12 inches (300mm), which after cover spalling, would leave 56% of the pre-spalled concrete area for well confined columns (i.e. columns having complying closely spaced ties and cross ties).*

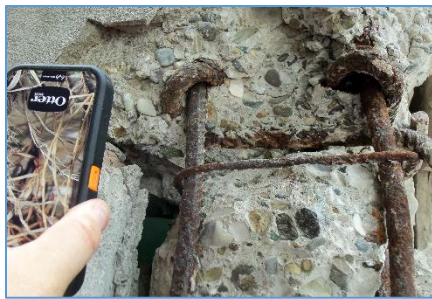
Material Deficiencies

Other common structural deficiencies observed were related to the construction materials and included severe rusting of reinforcing steel and the obvious low strength of much of the concrete (which was seen to be easily chipped by workers using hand tools). The use of beach sand for aggregate may be a likely reason for these deficiencies with the rebar and concrete strength, but this possible source is speculative at this point and is in need of further evaluation.

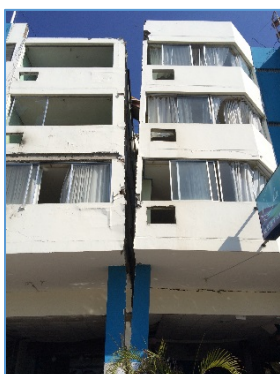
Adjacency & Interaction between Buildings

Structural interaction with adjacent structures (known as adjacency) is another area of concern related to seismic safety. Very common in Ecuadorian construction is the lack of a separation joint of more than a few millimeters, if at all, between adjacent buildings. Also at adjacent buildings, there is no code requirement that the adjacent floors align vertically in any manner. These conditions have in the past (during the Kobe Earthquake) contributed to total and partial building collapses, especially at buildings located at the end of a line (i.e. street corners) or taller buildings adjacent to shorter buildings, as the buildings impact each other and impart energy that neither buildings nor their columns, designed as a stand-alone, are designed to resist.

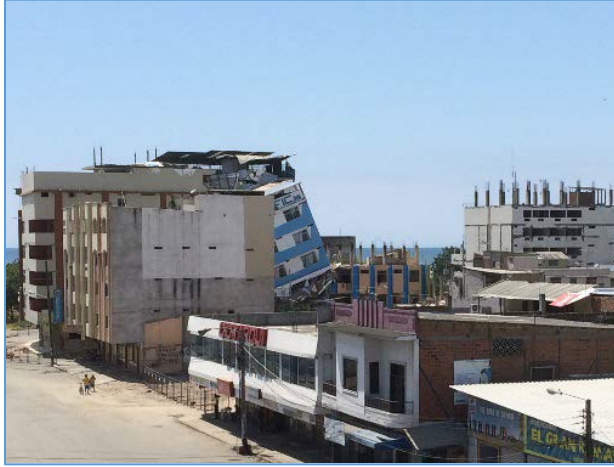
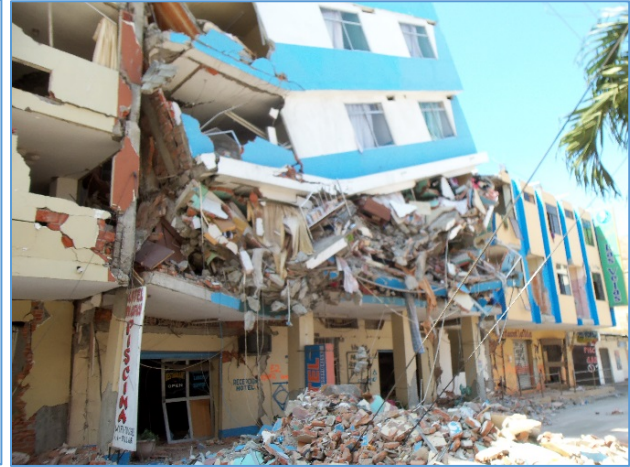
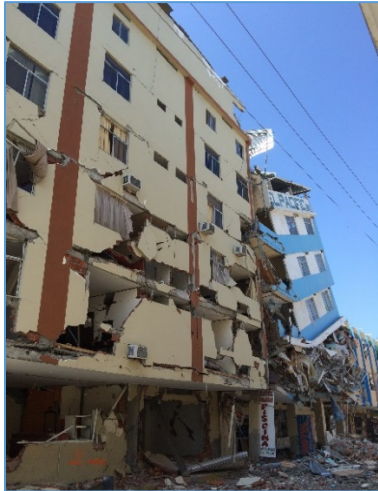
Manta: Pacific Hotel & Adjacent Bookstore (MMI VII)

Undersized and poorly detailed columns, adjacency and a vertical irregularity associated with mixed building height are the likely reason for the partial structural collapses of the Pacific Hotel and the complete collapse of the adjacent bookstore to the north. Cumulatively, these building collapses are responsible for killing over 96 people. Note that the floor slabs performed very well, yielding in a very ductile manner well into the non-linear range, while supporting a tremendous amount of weight from the collapsing building.

(It should be noted that during our reconnaissance, all of the building collapses that we observed were directly due to loss of column vertical strength). ABS Consulting observed very few flat slab punching shear strength loss mechanisms. For the few floor slab punching shear mechanisms we saw, all had been severely overloaded by structural debris falling from above and all still retained some residual strength consisting of “hanging” slab column-strip reinforcing steel. This column-strip steel, while severely damaged in many cases, prevented the total loss of vertical support of the floor).

In the case of the Pacific Hotel, column failure due to undersized columns and a lack of rebar tie confinement at the top and bottom of the columns was the primary mechanism for the hotel collapse. Luckily, the adjacent building to the south was constructed with columns having greater cross-sectional dimensions and was able to laterally support both itself and the toppling Pacific Hotel as well, thereby protecting many other lives. The Pacific Hotel lost four (4) intermediate stories due to partial collapse.

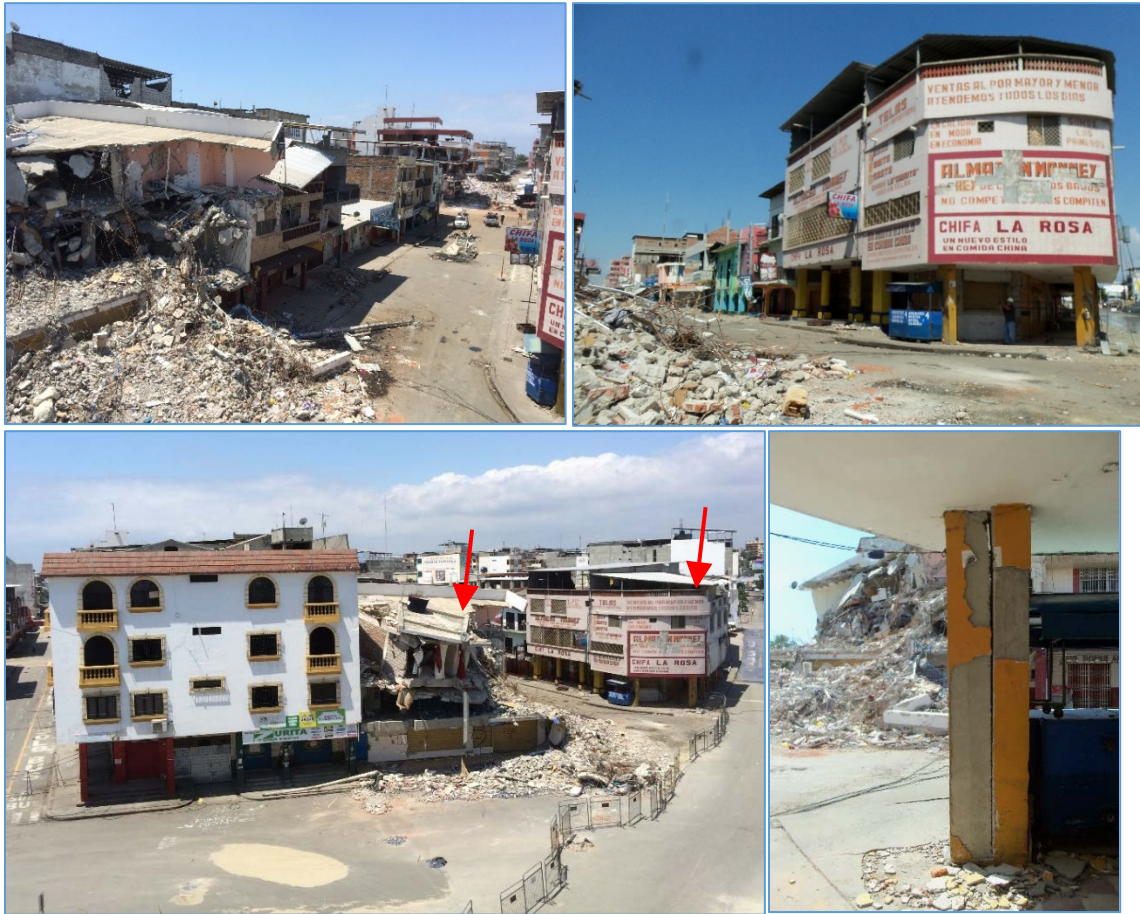
Manta: Chifa La Rosa Restaurant (MMI VII)

The Chifa La Rosa Restaurant building is a four-story non-ductile concrete structure with small columns located on an oblique street corner. The building is also trapezoidal in plan. These aspects alone would make the building highly susceptible to seismic damage and collapse during the strong earthquake ground shaking experienced in Manta. However, the building experienced very little observable structural damage.

Contrast this with the building across the street, also four-stories with undersized non-ductile columns - this building experienced a devastating partial collapse. Why did this building collapse and the Chifa La Rosa remain standing? Upon closer observations, the Chifa La Rosa Building Owner had retrofitted the building by widening the columns, adding nearly double the column area to the lower level. The reason for the column widening is unknown and may have been related to the addition of another floor level as opposed to as a seismic retrofit. *While this building retrofit is hardly a textbook example of quality by U.S. standards, we believe this is a great example of the benefits of actual/accidental seismic retrofit versus the “do nothing” alternative. The example also supports the assertion of these writers that undersized concrete columns were a fundamental reason for the numerous devastating structural collapses during the M7.8 Ecuador Earthquake.*

Note that the damage to the newer 4-story building with the mansard roof parapet to the left was also minimal. This building was constructed using improved standards and had significantly wider columns.

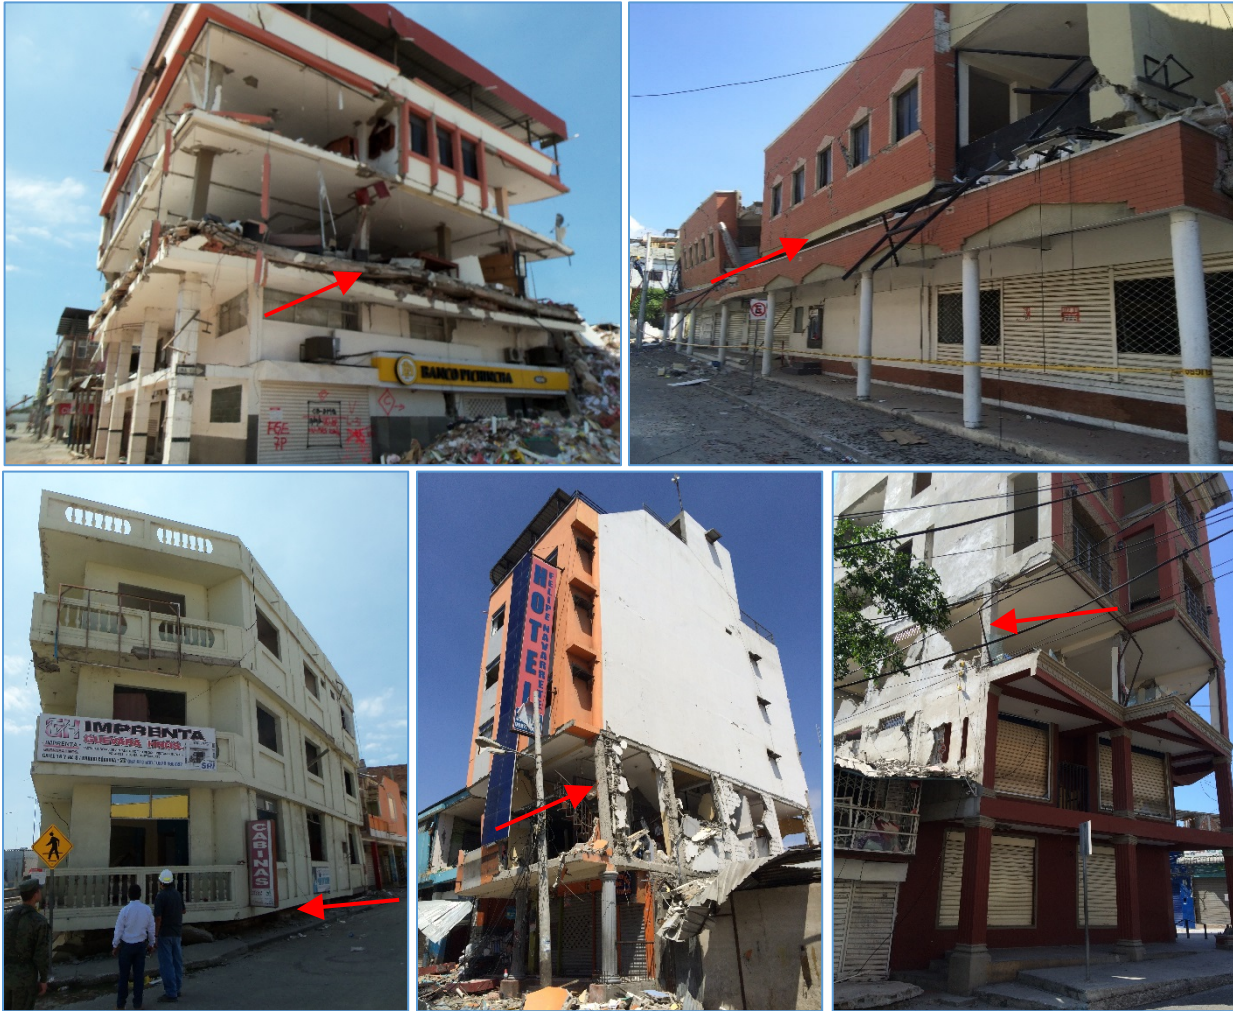
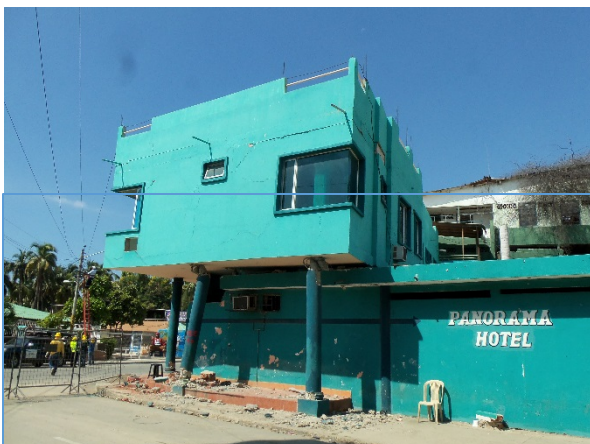
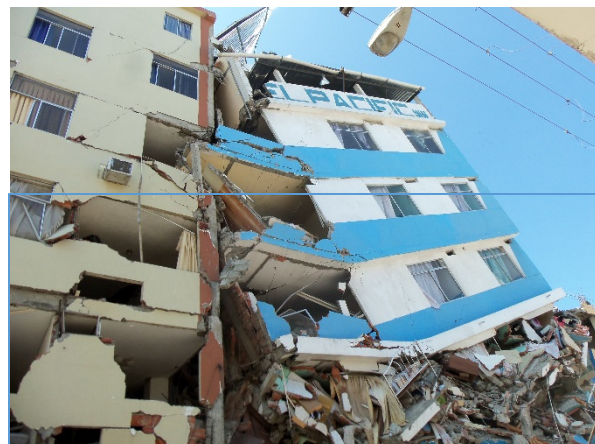
Manta: Various Partial Building Collapses (MMI VII)

Throughout the closed city zone there were several graphic examples of partial or impending story collapses at the intermediate or ground floor levels of buildings. All were characterized by the presence of undersized columns, by stepping column sizes down too quickly, or infill or adjacency issues related to impact from adjacent structures.

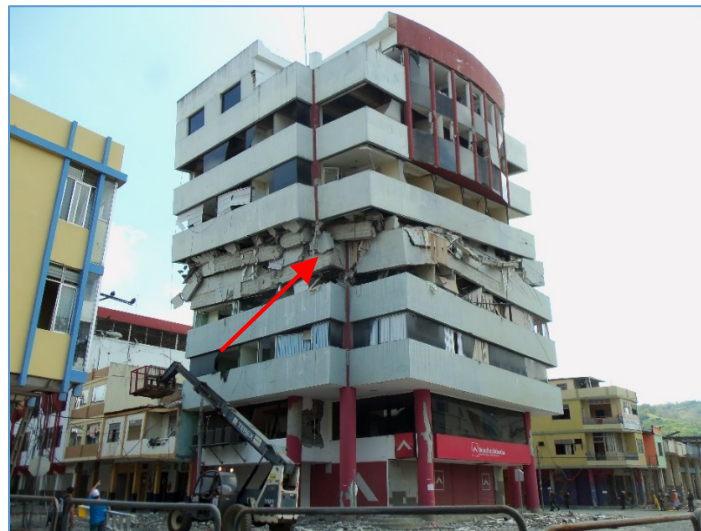
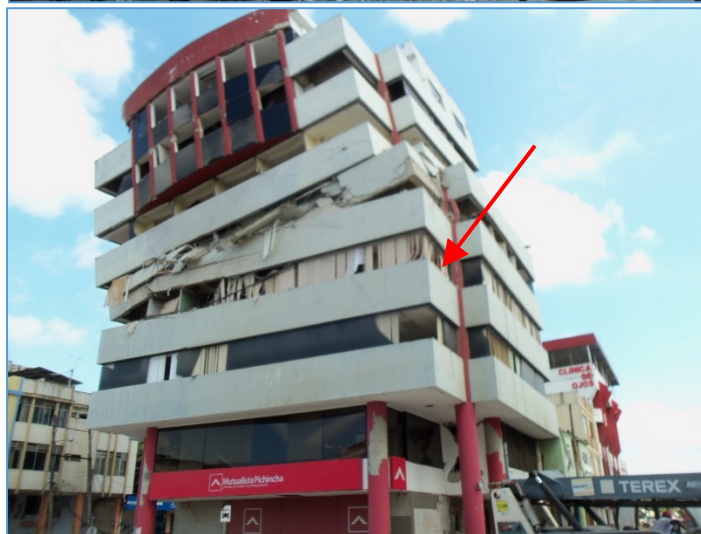
Portoviejo: Nine-Story Office Tower (MMI VII)

Lacking an adjacent building to create any interaction hazards, the cause of structural failure of the three intermediate floor levels (4-6) of this relatively modern nine-story building is obviously directly associated with the building's structural system. The failure is most likely related to critical damage to the short-captive columns (maroon colored) located at the reentrant corners. These "short" columns pull in substantially more lateral forces than the other non-captive columns at the floor level and are created by the placement of brick or concrete window wall cladding in direct contact with the column (red arrow added to the photo). Other contributors to the collapses include the likely stepping down (above the 3rd level) of the generally wide circular columns seen at the building base and interaction with the stiff interior brick partitions. The second mode vibrational characteristics of the building may have been amplified by the shaking at this location as well. Despite the easily noted eccentricity created by the story collapses, the structure was able to remain standing. Note the man-lift operator working in the vicinity despite the obvious potential danger.

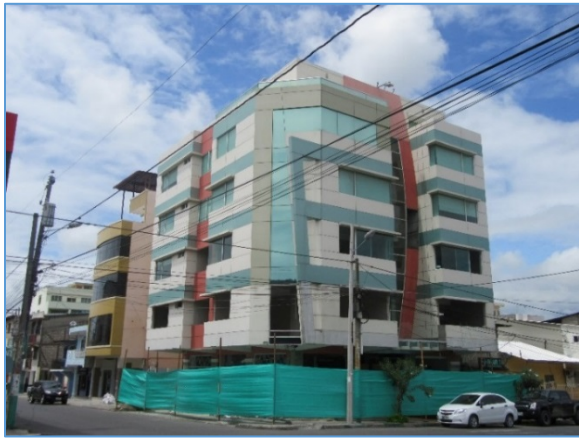
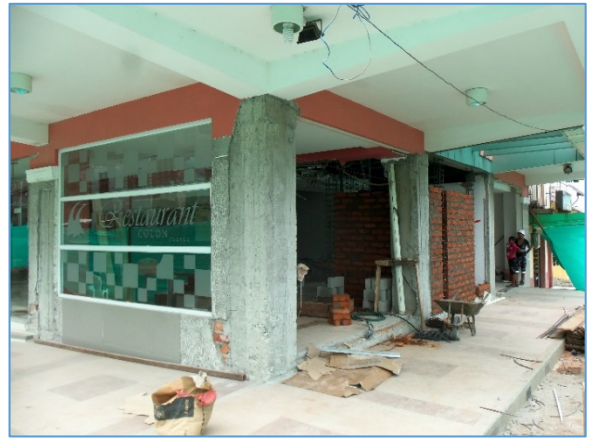
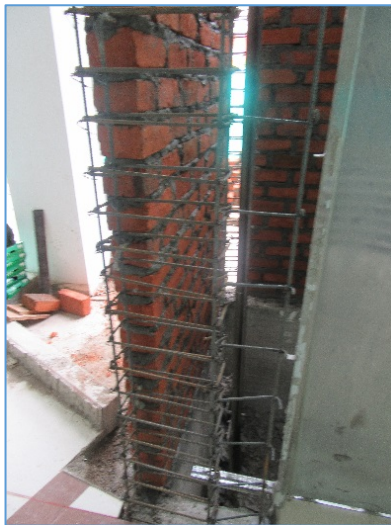
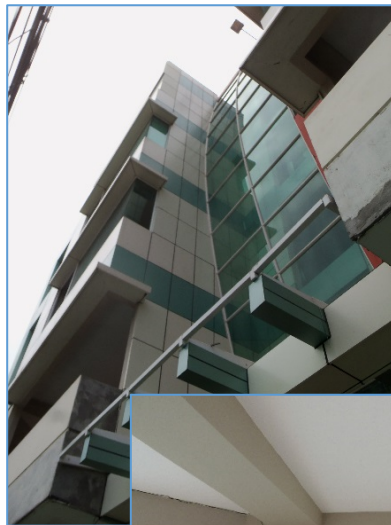
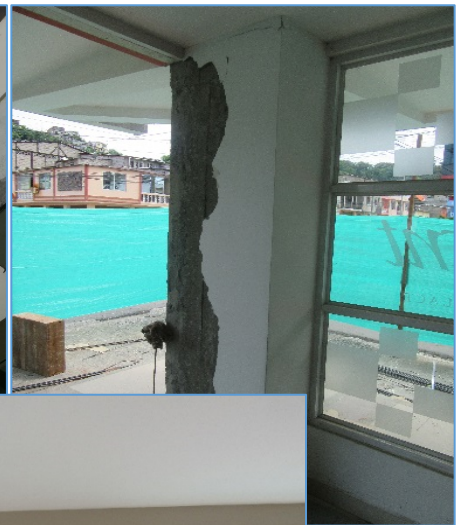
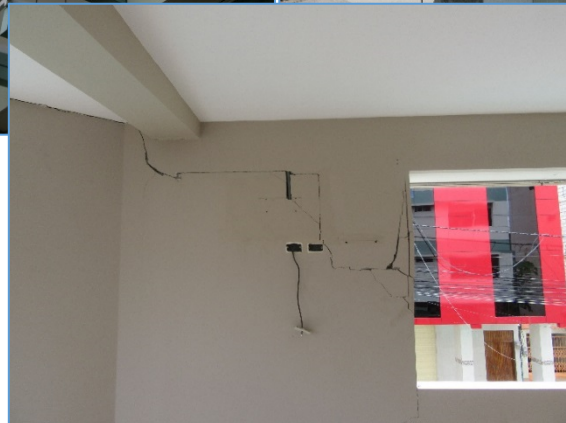
Esmeraldas: *Hotel Colon (MMI VI)*

Hotel Colon is a modern five-story reinforced concrete building with brick infill walls and partitions located near the civic center. The hotel was one of few major structures in Esmeraldas to exhibit any notable earthquake damage and, as a result, was not occupiable. Interior and exterior partition walls at the lower three stories showed readily observable diagonal earthquake X-shaped cracking and there was obvious damage to the exterior metal cladding and window glazing systems. However, the reinforced concrete columns were notably large by Ecuadorian standards and the column-flat slab structural frame was undamaged except for minor plaster spalling. Repair work at the time of ABS Consulting's observations were ongoing, with concrete stiffened brick elevator enclosure walls and partitions in the process of being reconstructed. Despite the lack of major structural damage, the downtime due to damage of non-structural elements for this locally high-end lodging facility is obviously significant.

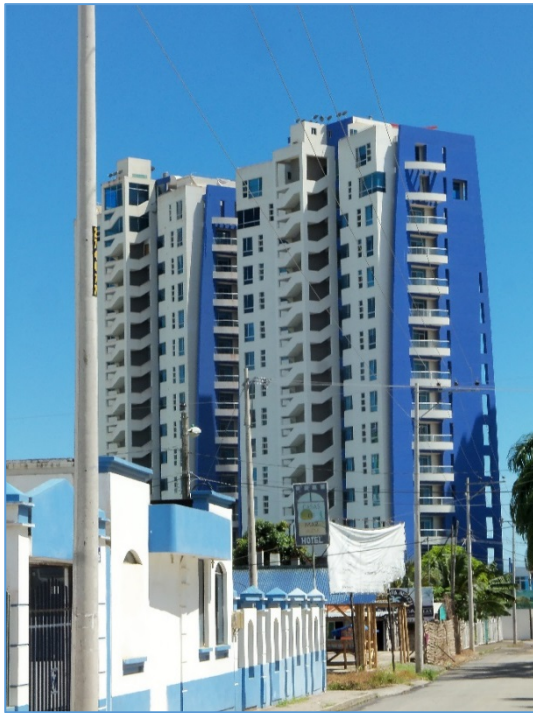
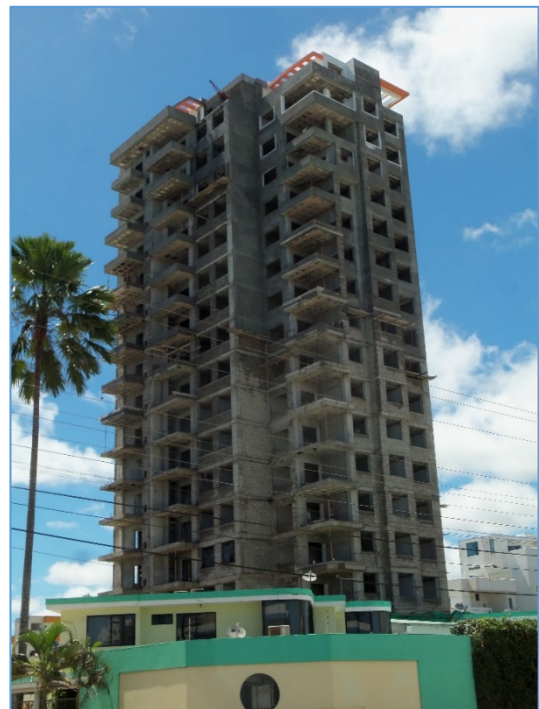
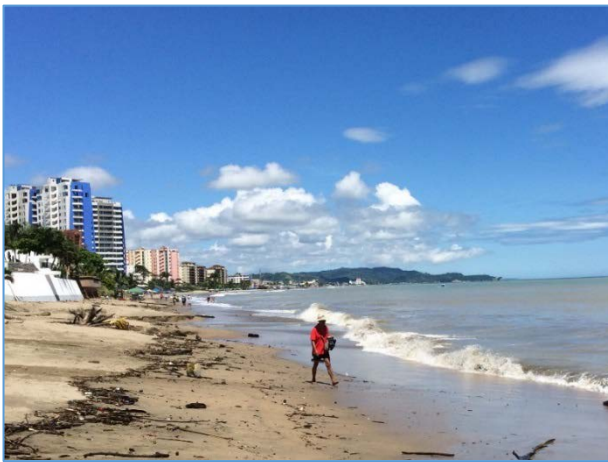
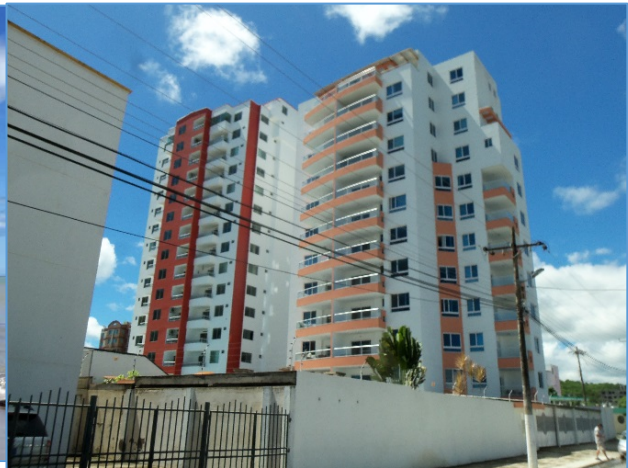
Tonsupa: High-Rise Residential/Hotel Towers (MMI VII)

Located in the region of Ecuador having the highest ground shaking intensity is the region of Atacames/Tonsupa. Despite the estimated 0.35g of peak ground acceleration by the M7.8 coastal earthquake (as listed on the USGS maps), Atacames/Tonsupa experienced very little damage to its buildings. Modern high-rise buildings being potentially wind-controlled and on piles would be expected to experience less earthquake damage. However, even the older two to six-story structures located in the older sections of this area experienced little damage. Looking at the exposed portion of the steep but low sea cliff, it appears that the soil here is largely dense clay with some cobbly alluvial lenses, which may have been a factor. Considering the low volume of earthquake damage in this area, it is questionable that the shaking was as high as MMI=VII, and was probably closer to MMI=VI. Despite having almost no damage, the resort area was experiencing a significant reduction in occupancy since most Ecuadorians were afraid of collapses due to aftershocks.

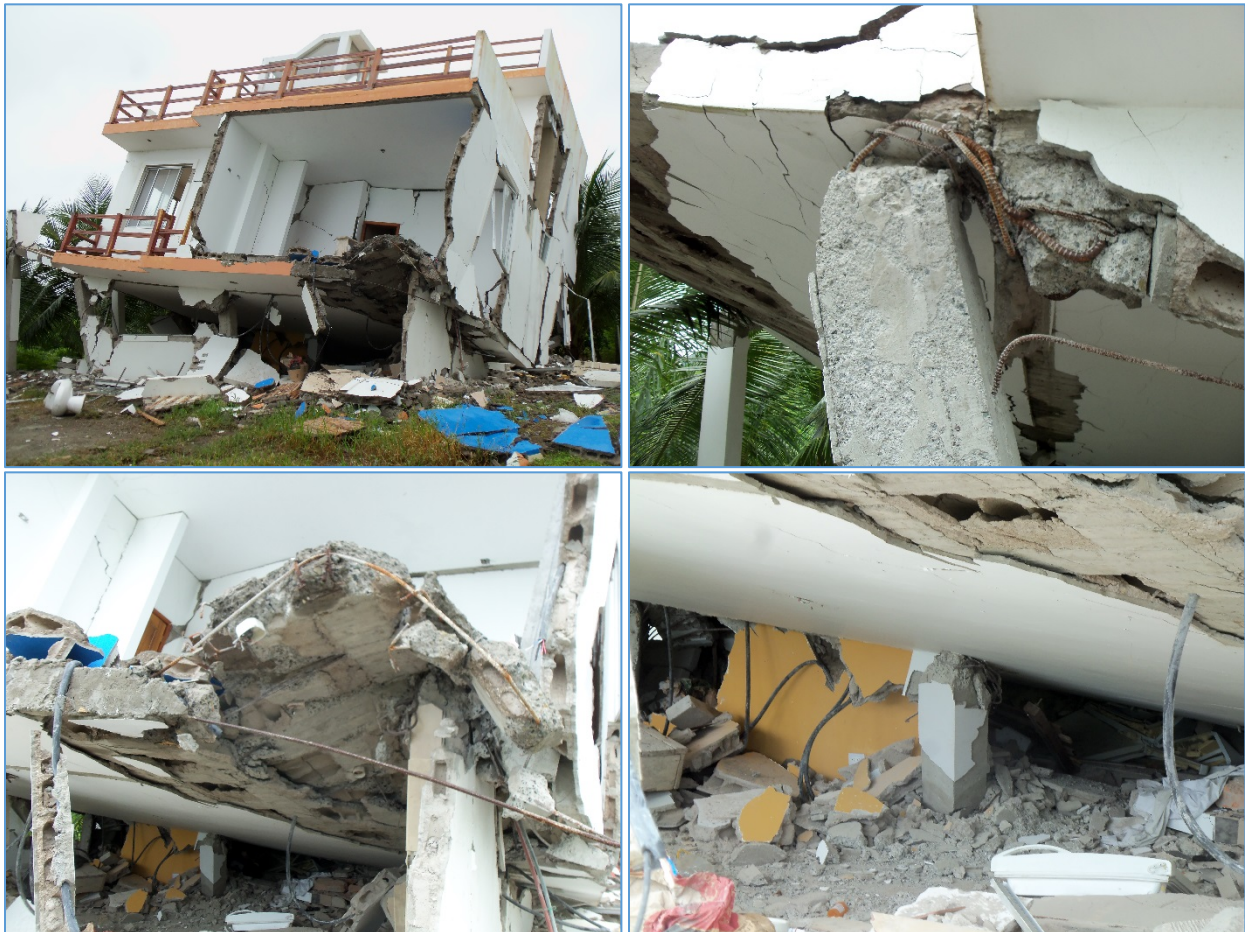
South of Pedernales: Family Residence (MMI VIII)

Undersized and poorly detailed columns and a non-uniform arrangement of interior and exterior block masonry partitions are the likely reason for the partial structural collapses of this new three-story home. The upper “living space” levels were laid out with multiple brick partitions to create room separations, whereas the lower ground level was largely “open”. While not directly considered on the structural analysis, these brick partitions provide for substantial strength and stiffness, making those floors with notably less partitions weak and flexible in comparison. Once the brick partitions loose strength at a particular level, only the undersized columns remain at that level to laterally support the building during earthquake shaking. The undersized columns provided were too weak to force any desirable yielding to occur at the adjacent or upper levels, which forces a yielding/strength loss mechanism into the columns at that level. After a few displacement cycles with poor non-ductile detailing in the undersized columns, vertical strength loss in the columns began, and loss of vertical support and collapse at that floor level was eminent.

Note again that the “waffle” floor slabs performed very well, yielding in a very ductile manner well into the non-linear range, while supporting a tremendous amount of weight from the collapsing building.

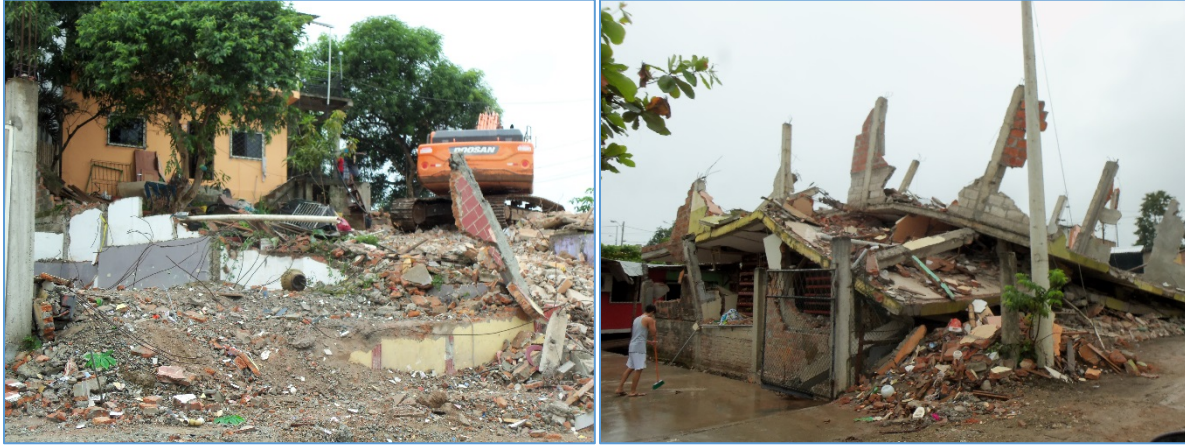
Pedernales: Widespread Damage & Collapse (MMI VIII)

Located on rolling hills approximately 26 kilometers from the epicenter, the community of Pedernales was devastated by the earthquake ground shaking. Many of the recorded deaths occurred in this area. As opposed to other areas to the south that had localized damage zones (closed zones) that fell into more or less construction vintages or presumed soil types, the entire Pedernales region was devastated. In reality, the whole town was a “closed zone”. Building collapses and ground and foundation failures were widespread, occurring near the beachfront, on hillsides, and hilltops alike, mostly to older structures, but in many cases brand new buildings under construction or nearing completion. Based on what we saw, 100% of the structures in this city experienced damage, mostly extensive and a large fraction of the taller or marginal structures outright collapsed at one, multiple, or all floor levels.

Some very light traditional lightweight Ecuadorian residences on cantilever columns survived with surprisingly little damage.

Many of the non-ductile concrete resort hotels along the beachfront strip collapsed and the roadways still bear the ground ruptures that resulted from the pressure wave created from their collapses. Some are still standing but are in the process of toppling, leaning precariously towards the downhill side. Still in the clearing stages of much of the rubble, the community is starting to rebuild. However, the damage is so extensive that this earthquake will likely have an impact for decades.

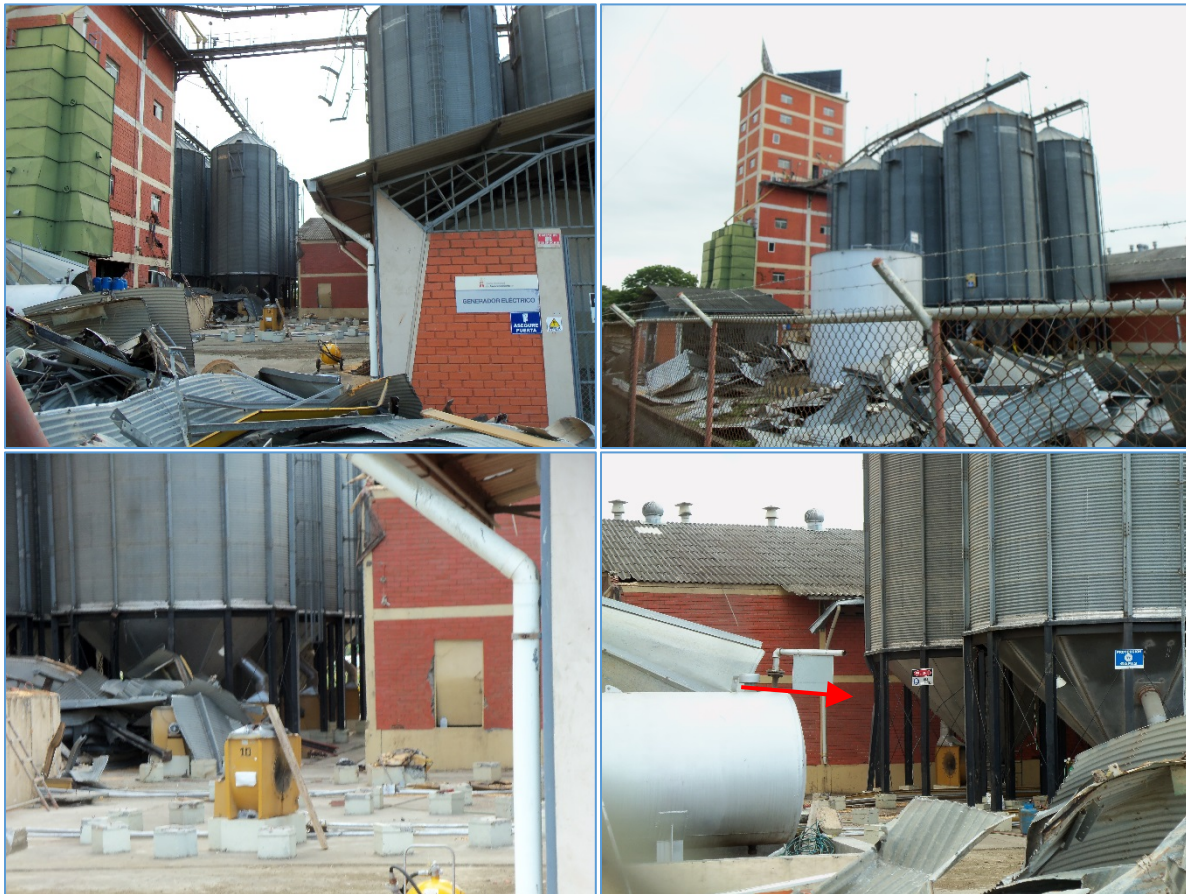
Portoviejo: Grain Storage Facility (MMI VII)

Earthquake related damage to several cylindrical corrugated-metal steel-framed grain storage silos on legs was observed. In this case, the support of all four silos closest to the grain elevator building failed. While the reason for the collapses of these particular silos is uncertain, a buckled leg was observed (see photo). Based on our observations, it is probably likely that these silos were partially full, while the other silos still standing and mostly undamaged were mostly empty. Based on damage to the anchor bolt connections at the base of the legs and some buckled legs (see red arrow), the silo failures were most likely due to a combination of anchor bolt failure on the uplift side and then leg buckling on the compression side under seismic lateral overturning forces.

The grain elevator building and ancillary storage building structures were mostly undamaged, except for some damage to the brick infill and lightweight roof related to frame racking and collapsing silos. The silos fell down away from the elevated conveyor lines, which sagged, but somehow did not fall.

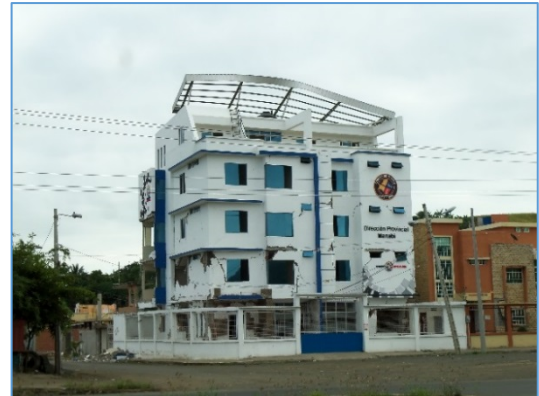
In Portoviejo (MMI VII) a brand new Government reinforced concrete building in the Manabi district suffered extensive brick infill wall damage as well as column structural damage. It appears that soil soft conditions at the building site contributed to the damage.

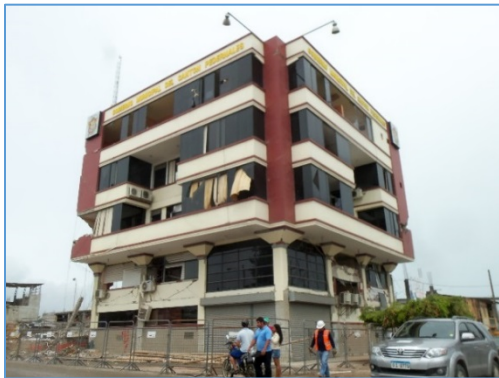
A five-story concrete city government office building in Pedernales (MMI VIII) suffered extensive damage to brick infill walls and window glazing.

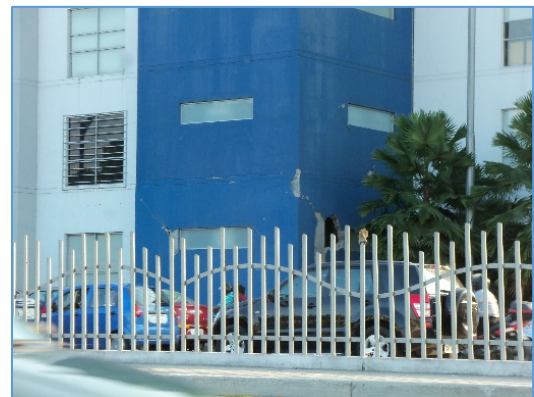
In Guayaquil (MMI V), a reinforced concrete building for the Ministry of the Interior (located in the Avenida de Las Americas) experienced brick infill wall damage. This damage may be related to locally-occurring soft soils in the area that possibly amplified the shaking.

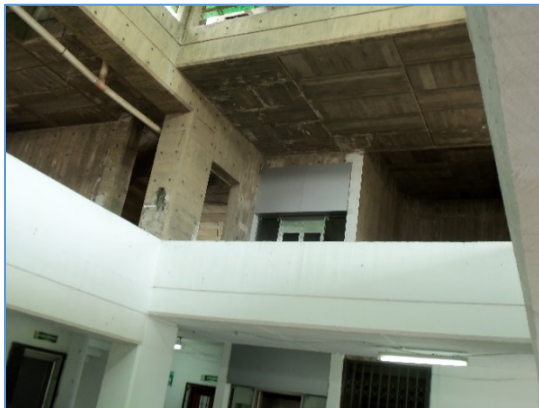
In Esmeraldas (MMI VI), a three-story reinforced concrete-frame/shear wall city government office building suffered minor brick infill partition damage. The building appears to have adequate sized columns and beams.

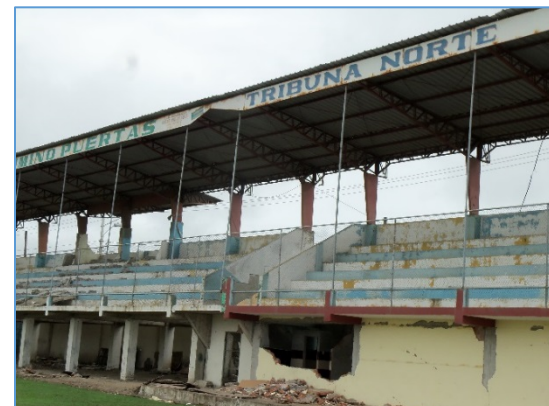
In Pedernales (MMI VIII), an older reinforced concrete stadium that was constructed with substantial column and beam framing and a light steel framed roof had

little structural damage, except for an unreinforced masonry press box.

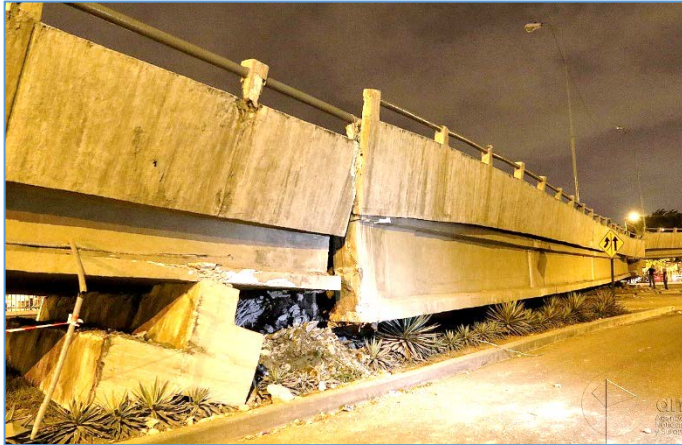
Traffic Overpass in Guayaquil (MMI V)

A portion of the reinforced concrete overpass on the Avenida de Las Americas in front of the University Vicente Rocafuerte and near the airport collapsed. Another section of the same bridge suffered damage but did not collapse, and is shored awaiting repair. This overpass was constructed circa 1980 and is a prominent component of the main connection between the North and Central areas of Guayaquil. At least one causality is attributed to the collapse. Based on photographs taken by others immediately

after the earthquake, the collapse appears to be related to an initial stability loss at the shorter bridge buttresses, which toppled in the parallel to roadway direction. The failure of this bridge is surprising because the ground shaking intensity in Guayaquil (280 kilometers from the epicenter) was only MMI V (approximately 0.07g).

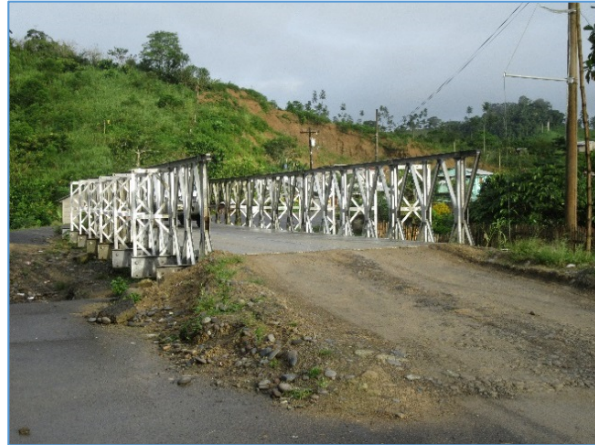
Bridge and Roadway Embankment Damage Highway between Muisne and Esmeraldas (MMI VII to VIII)

A small bridge on the route between Muisne and Esmeraldas collapsed during the earthquake ground shaking and had been replaced by a temporary steel bridge. It is suspected that the bearing supports on the embankment on one side of this bridge failed during the earthquake.

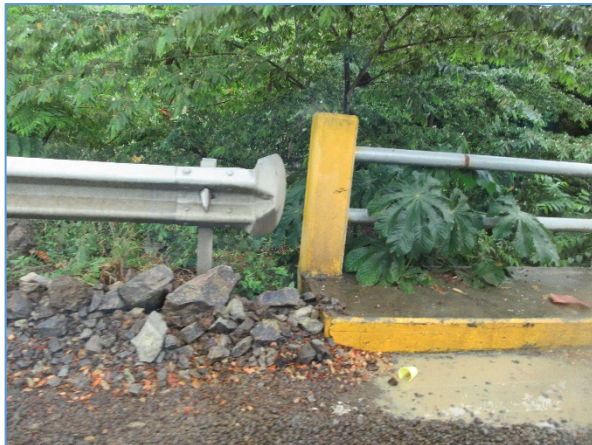
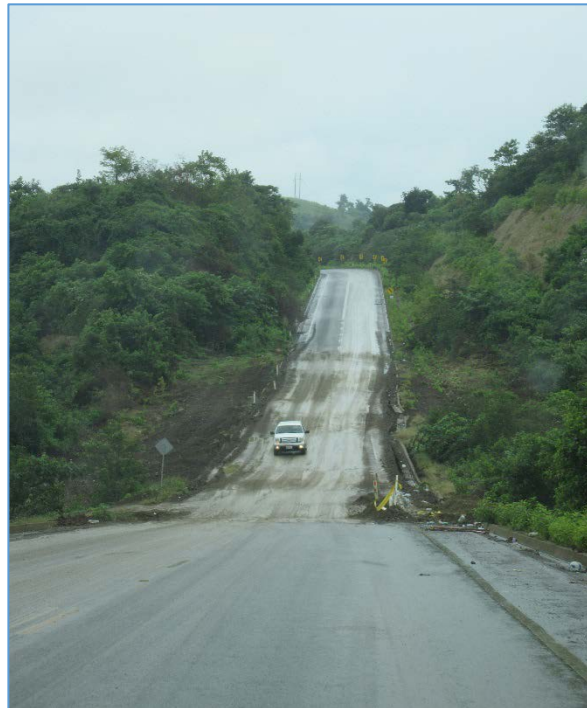
Along this route, ABS Consulting noted numerous minor settlements to roadway embankment “fills”, especially predominant at valleys where the bottom of the “vertical curve” roadway layout occurs, and at bridge transitions.

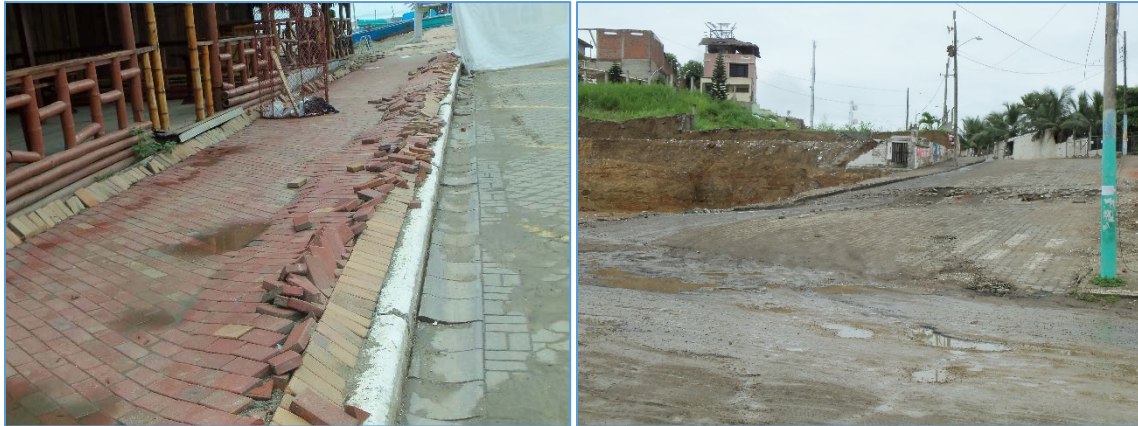
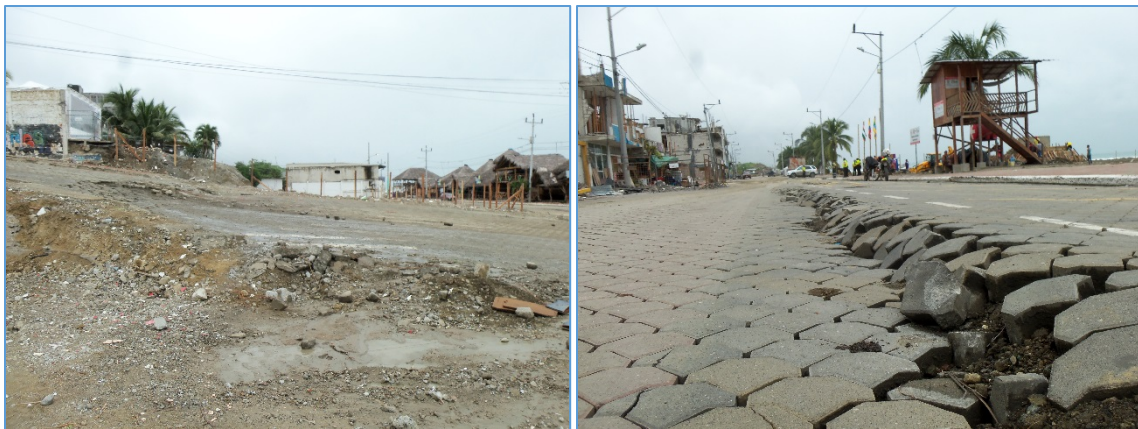
Soil Failures & Landslides

Signs of soil liquefaction, soil failure associated with high water table, and possible soil settlement were observed at the coastal cities of Manta, Pedernales and Muisne. Some of the soil disruption noted along the oceanfront road in Pedernales (MMI VIII, photos below) may have been exacerbated by the impact force and created “soil wave” associated with the total vertical collapse of two large beach-front hotels that have been subsequently demolished.

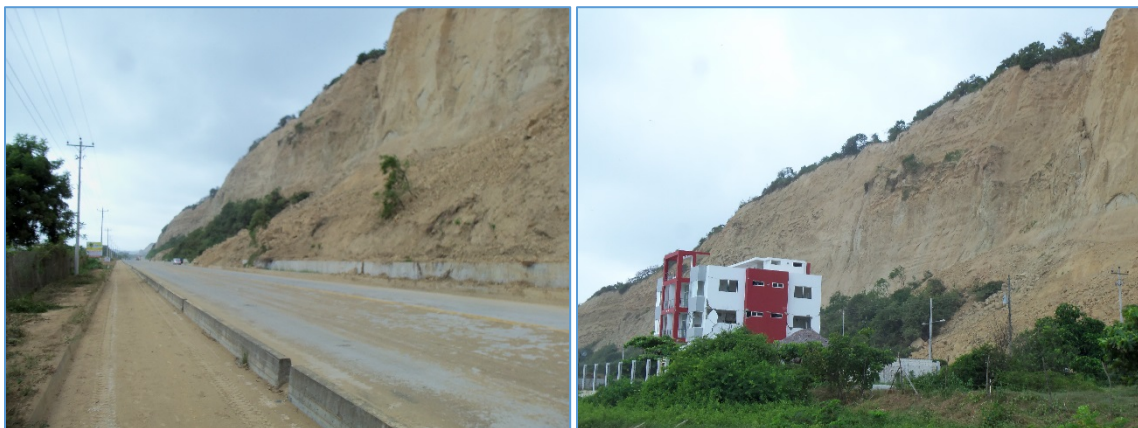
Small landslides at some roadway cuts were observed while driving the ocean highway between Manta and Pedernales.
