M7.8 COASTAL ECUADOR EARTHQUAKE PRELIMINARY RECONNAISSANCE REPORT

By ABS CONSULTING, AN ABS GROUP COMPANY
MAY 31, 2016

Preliminary ABS Consulting Reconnaissance Report May 31, 2016

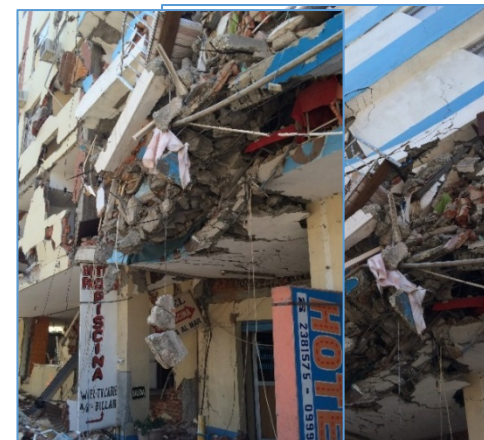
In the case of the Pacific Hotel, column failure due to undersized columns and a lack of rebar tie confinement at the top and bottom of the columns was the primary mechanism for the hotel collapse. Luckily, the adjacent building to the south was constructed with columns having greater cross-sectional dimensions and was able to laterally support both itself and the toppling Pacific Hotel as well, thereby protecting many other lives. The Pacific Hotel lost four (4) intermediate stories due to partial collapse.

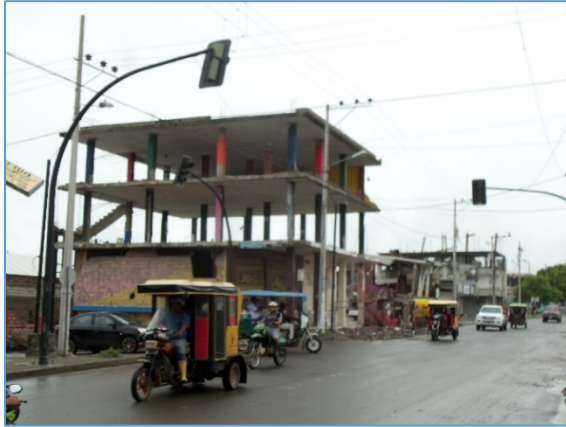
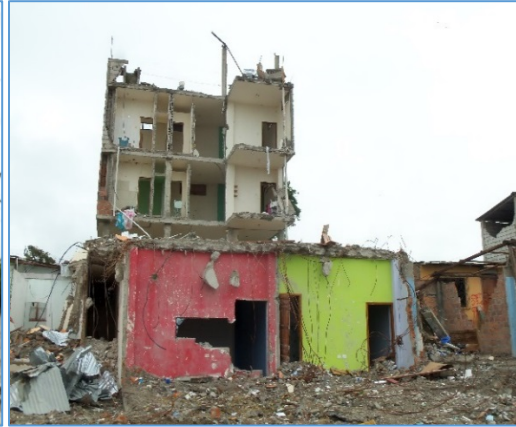
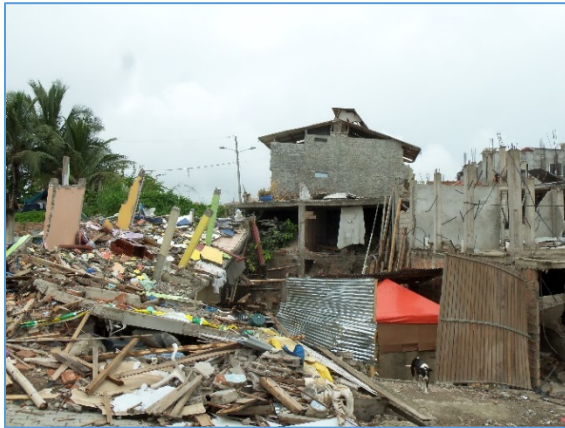
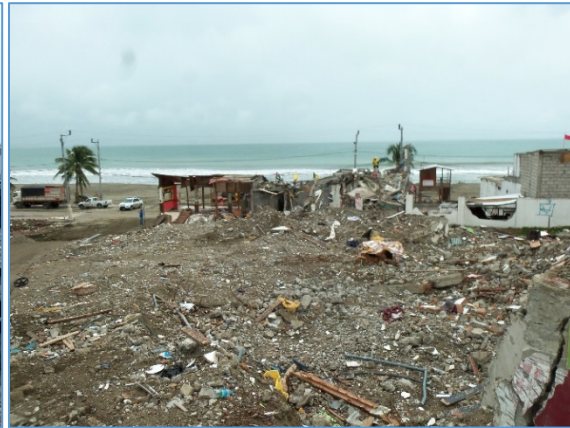
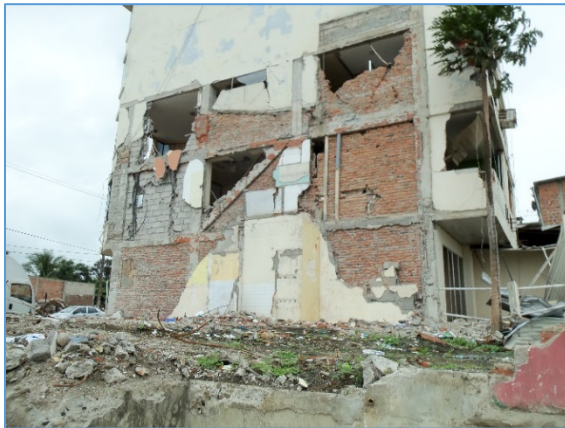
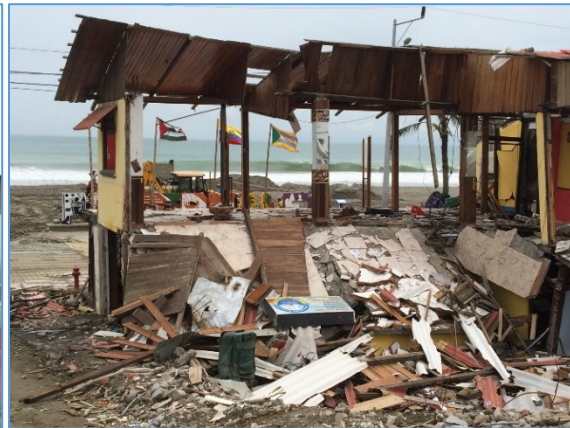
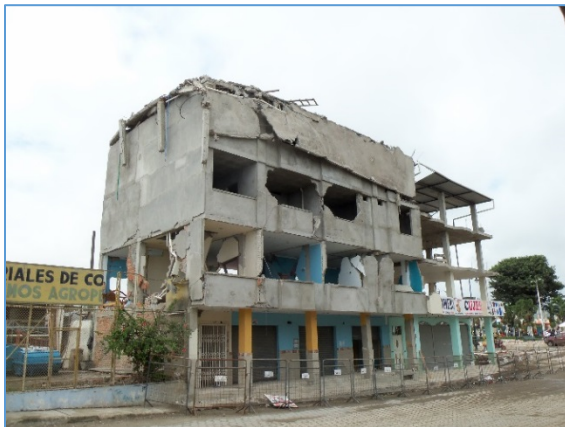
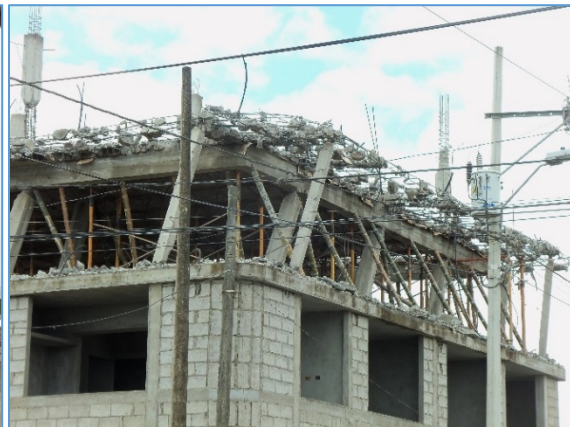
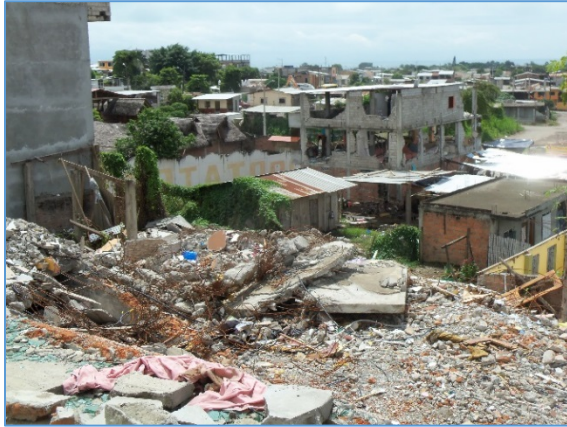
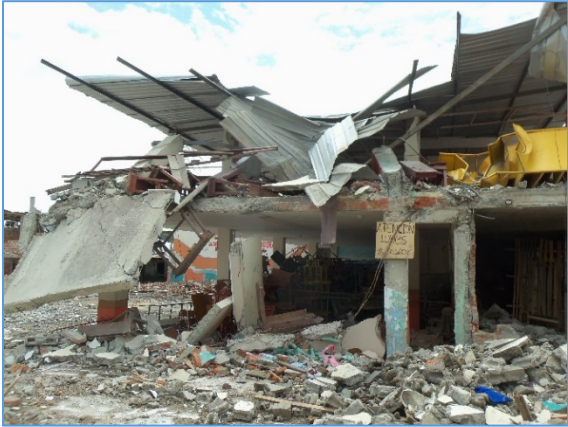
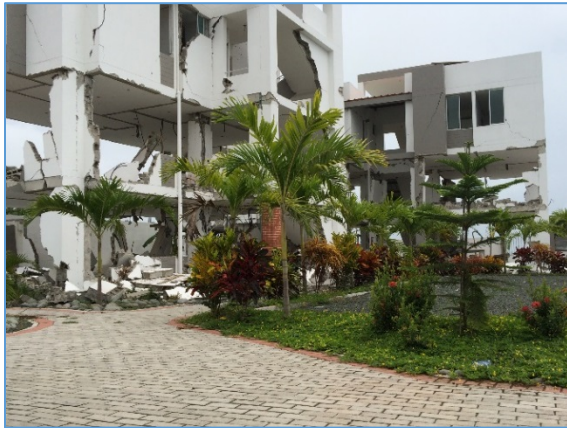
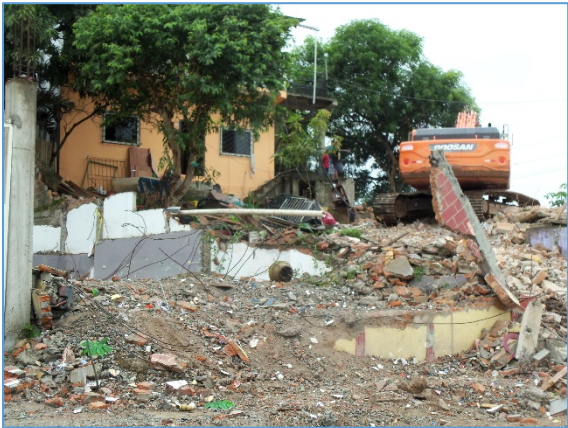
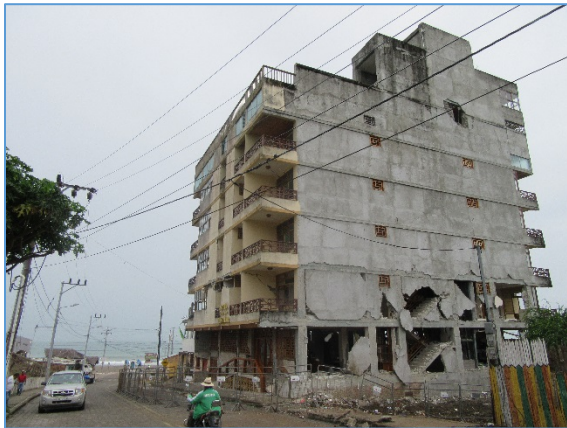
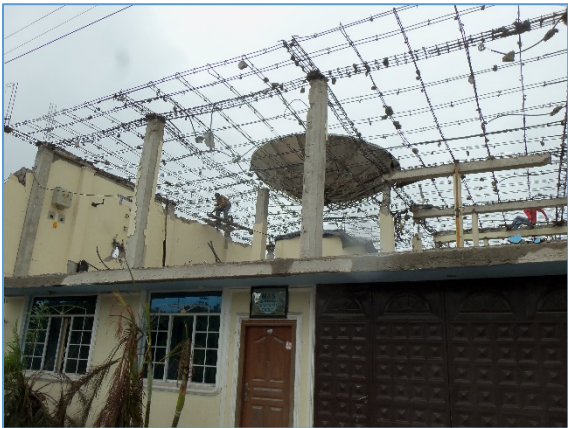
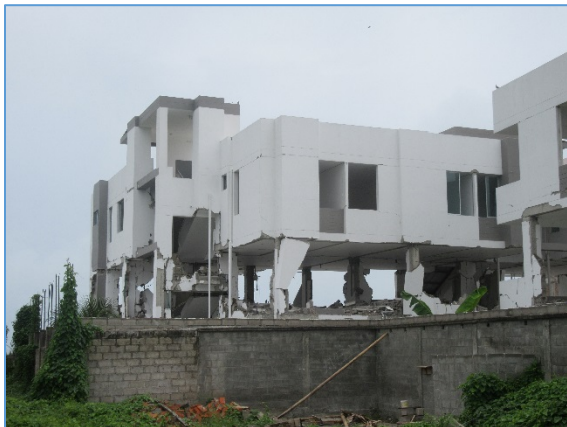
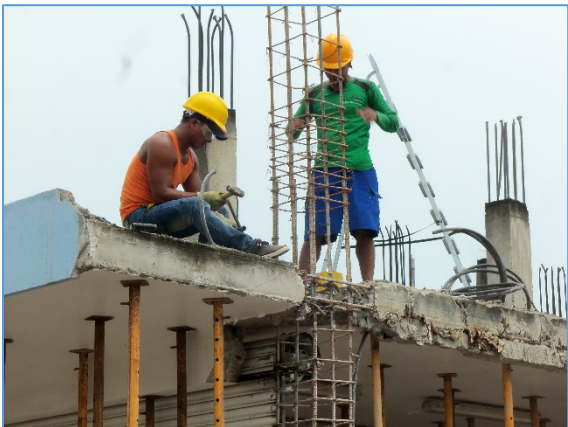
Pedernales: Widespread Damage & Collapse (MMI VIII)

Located on rolling hills approximately 26 kilometers from the epicenter, the community of Pedernales was devastated by the earthquake ground shaking. Many of the recorded deaths occurred in this area. As opposed to other areas to the south that had localized damage zones (closed zones) that fell into more or less construction vintages or presumed soil types, the entire Pedernales region was devastated. In reality, the whole town was a “closed zone”. Building collapses and ground and foundation failures were widespread, occurring near the beachfront, on hillsides, and hilltops alike, mostly to older structures, but in many cases brand new buildings under construction or nearing completion. Based on what we saw, 100% of the structures in this city experienced damage, mostly extensive and a large fraction of the taller or marginal structures outright collapsed at one, multiple, or all floor levels.

Some very light traditional lightweight Ecuadorian residences on cantilever columns survived with surprisingly little damage.

Many of the non-ductile concrete resort hotels along the beachfront strip collapsed and the roadways still bear the ground ruptures that resulted from the pressure wave created from their collapses. Some are still standing but are in the process of toppling, leaning precariously towards the downhill side. Still in the clearing stages of much of the rubble, the community is starting to rebuild. However, the damage is so extensive that this earthquake will likely have an impact for decades.

According to the shaking mapping in USGS report, the peak ground acceleration in Pedernales was on the order of 0.37g. The local and federal police had a strong presence throughout and UNICEF had set up at least two large relief camps.

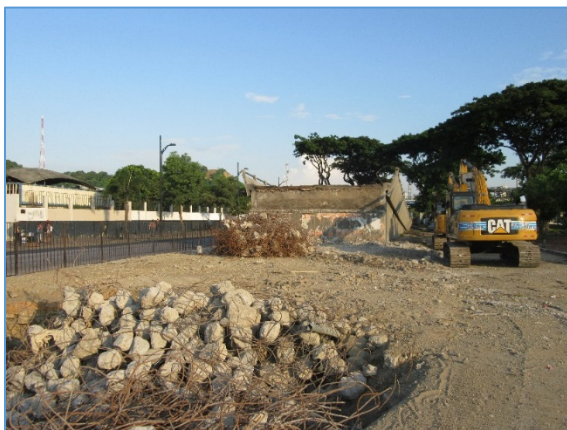
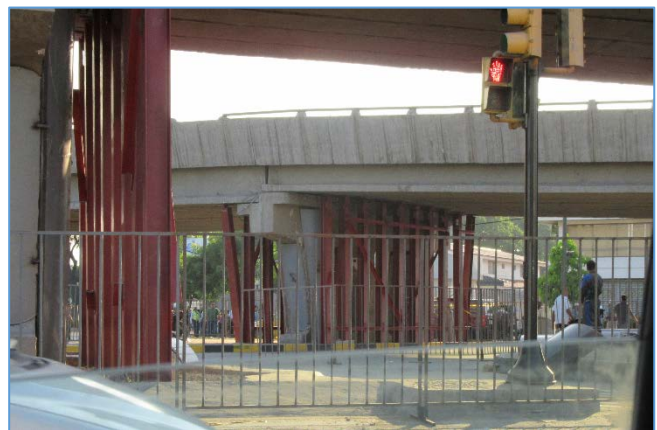
A portion of the reinforced concrete overpass on the Avenida de Las Americas in front of the University Vicente Rocafuerte and near the airport collapsed. Another section of the same bridge suffered damage but did not collapse, and is shored awaiting repair. This overpass was constructed circa 1980 and is a prominent component of the main connection between the North and Central areas of Guayaquil. At least one causality is attributed to the collapse. Based on photographs taken by others immediately

after the earthquake, the collapse appears to be related to an initial stability loss at the shorter bridge buttresses, which toppled in the parallel to roadway direction. The failure of this bridge is surprising because the ground shaking intensity in Guayaquil (280 kilometers from the epicenter) was only MMI V (approximately 0.07g).

Interestingly (and as indicated before) the only other notable earthquake damage we observed in Guayaquil was some brick infill damage at the Ministry of the Interior building directly adjacent to the overpass. This may be potential evidence of some locally occurring soft soils in the area that possibly amplified the shaking.
